UNPREDICTED PIPELINE EXPLOSION

Article originally published in the Institute of Chemical Engineers Loss Prevention

Issue 174 December 2003

DRB Materials Technology (Mattech) of Lymington is a group of consulting engineers providing solutions to technological problems for industries of all types covering failure investigation, corrosion, welding engineering, maintenance, risk assessment etc. One of its recent investigations involving a pipeline explosion, see Fig. 1, provides valuable information for pipeline operators.

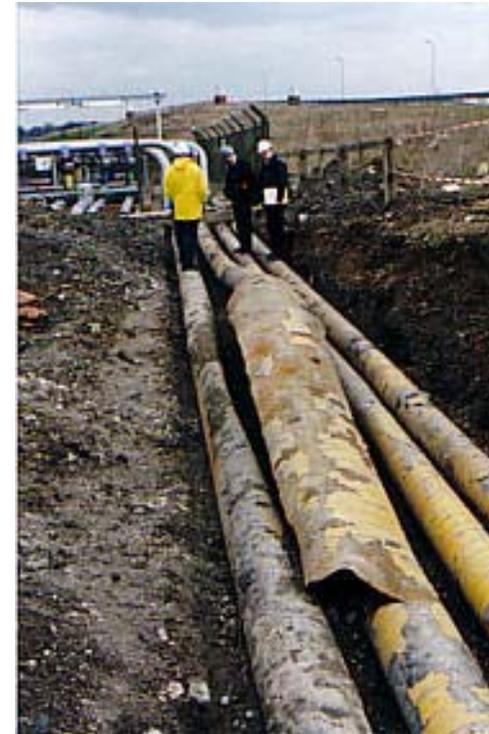
Fig. 1. General View of Surface Pipeline Explosion

The largest explosion was in the buried section of the line, see Fig.1. It was thought by the operators of the line to be the origin of the explosion and, initially, attention was concentrated here.

In Figs 1 & 2, the largest area of damage is seen and in Fig. 11 another example of damage is seen, both of these were shown by fractographic examination to have characteristics typical of ductile tearing, for this and other reasons, brittle fracture at these locations were therefore ruled out. Other examples of damage were less extensive and one of these is seen in Fig.5 where cracking of the seat on a spade used to isolate the line can be seen. It was possible that this cracking had been the source of ingress of air or alternatively it may have entered via the fracture of the small bore connection seen in Fig. 3. Another possibility was the cracking found on the welded region between the nozzle and the main line, see Fig. 4.

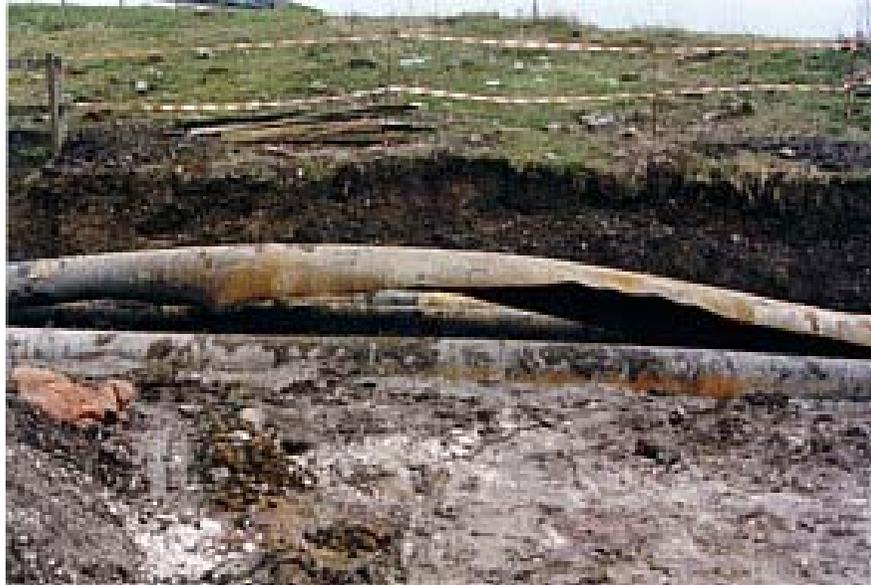
Fig. 2. Side view of exploded pipe.

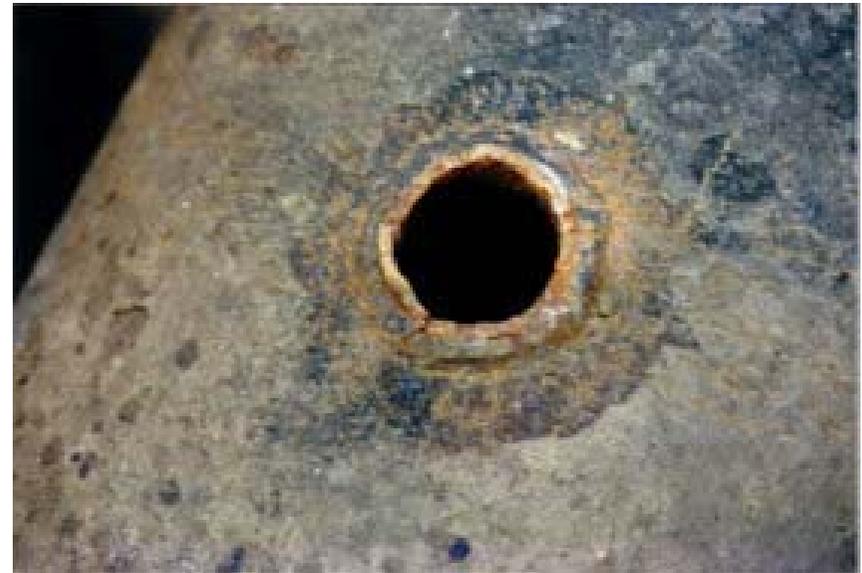
Fig. 3. Weld on main Line, residue beneath 1.5" valve, note cracking in the weld and Luder lines around weld indicating stress field. This was removed for metallographic investigation.

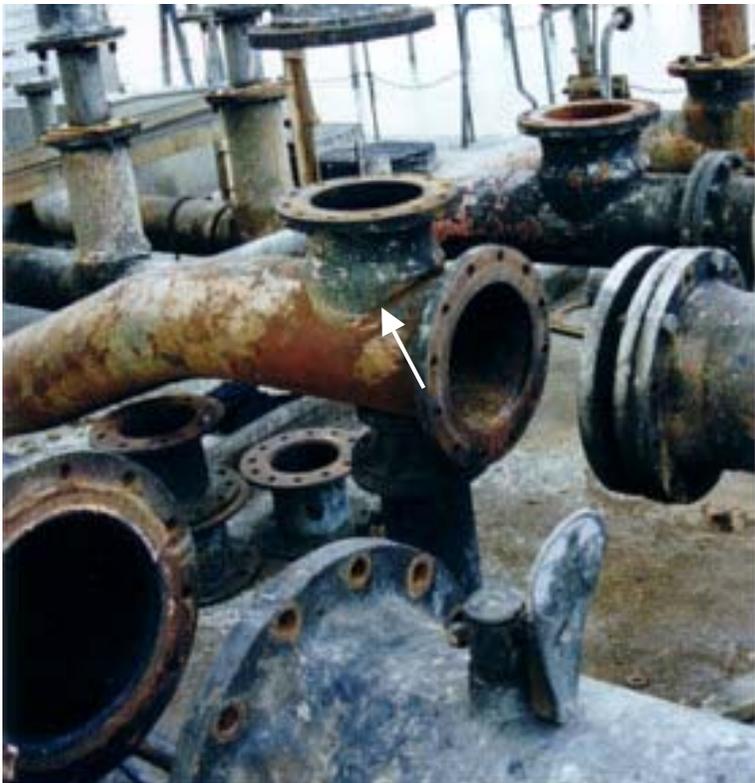
Fig. 4. Nozzle remote from explosion, note crack propagating from weld, investigated as possible source of air ingress

- Failure to follow the safety procedure for pigging, thus allowing air ingress and producing an explosive mixture.
- Entry of air into the line via a gasket leak, faulty valve gland packing or crack producing an explosive mixture.
- Entry of air via a crack or a defect in a weld, as seen in Fig. 4 or from the detachment of a small bore connection as seen in Fig. 3. Around this small bore connection, Luder lines can be seen causing rusting in the paint film. These Luder lines are indicative of stress resulting from applied load. Load could have been applied in service or at the time of the explosion.

- Fatigue of the line at regions of stress concentration such as welds and this was a possibility in the crack seen in Fig. 4.
- Brittle fracture. This generally occurs at low temperatures. The line explosion had occurred in the month of February when

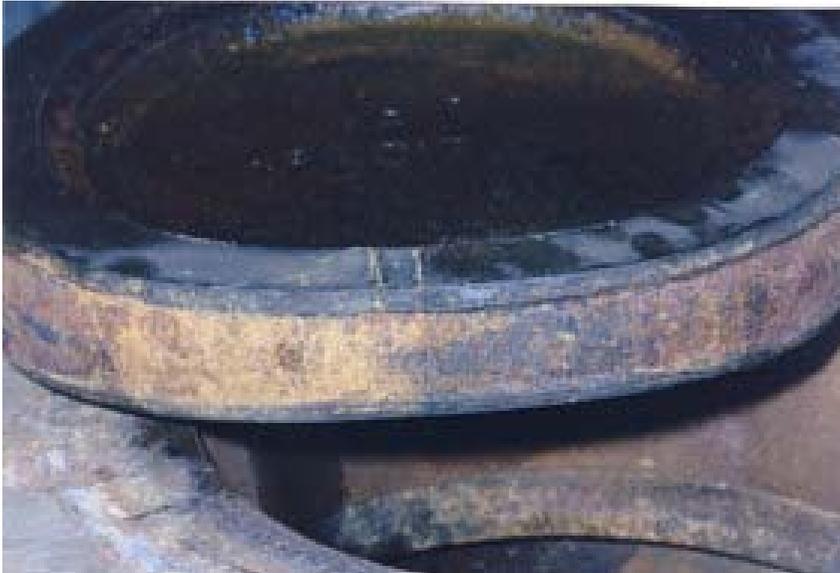
Fig. 5. Fracture on seat ring of isolating spade, investigated as possible origin of air ingress

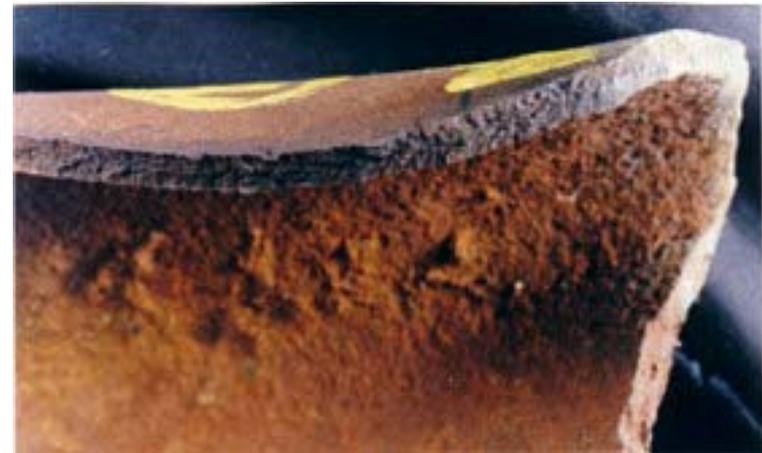
By following fractographic features, such as are shown in Fig 6, it is possible to identify the origin (the point from which the crack commenced) and the direction of travel of a propagated fracture. This was performed on all fracture faces and origins were found but metallographic examination indicated that none of these were defects in the material and thus they were the results of the explosion and not the causes.

Fig. 6. Fracture Face with Chevrons indicating origin of fracture and direction of travel.

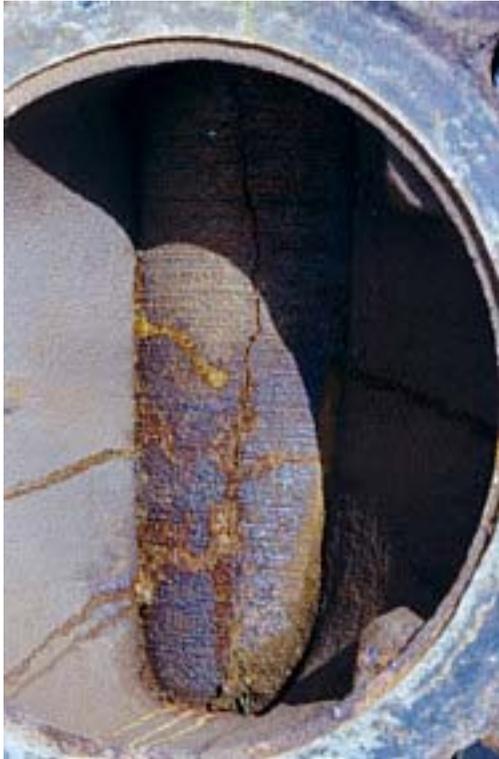
Fig. 7 Cracking in upstream side of plug valve this valve was located above an exploded region of the pipeline

As part of the investigation, valves were removed for examination. It was noted that the plug of one valve was cracked, see Fig.7. This was located on the upstream of the valve, which was positioned on the unused line above the explosion damage seen in Fig. 11. On the downstream side of

this plug valve, large pieces of the plug were found to be missing. In the explosion, the pig trap door was blown off and was not recovered and it is probable that the parts of the plug were also blow out of this door.

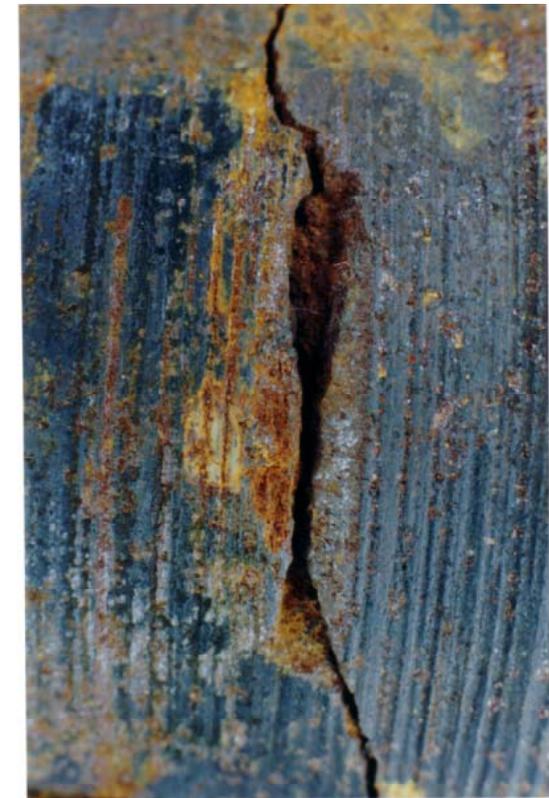
Fig. 8 Typical Cracking in plug on upstream side of valve.

the cast iron material of construction had suffered corrosion and this had resulted in intergranular cracking. It was therefore apparent that the fracture here had been present prior to the explosion.

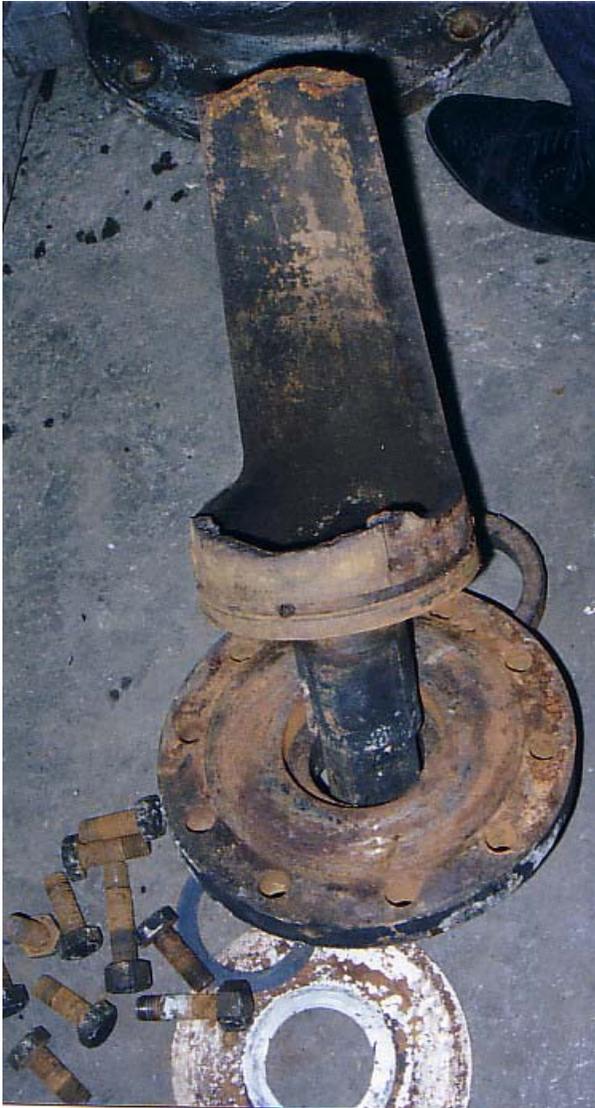
Fig. 9 Fractured plug with downstream side missing

It was concluded that inadequate maintenance was the root cause of the explosion. The plug valve which had fractured did not appear ever to have been either lubricated or inspected since it was effectively bonded into its seat by corrosion products and the plug had suffered intergranular attack which had propagated to the extent that fracture eventuated.

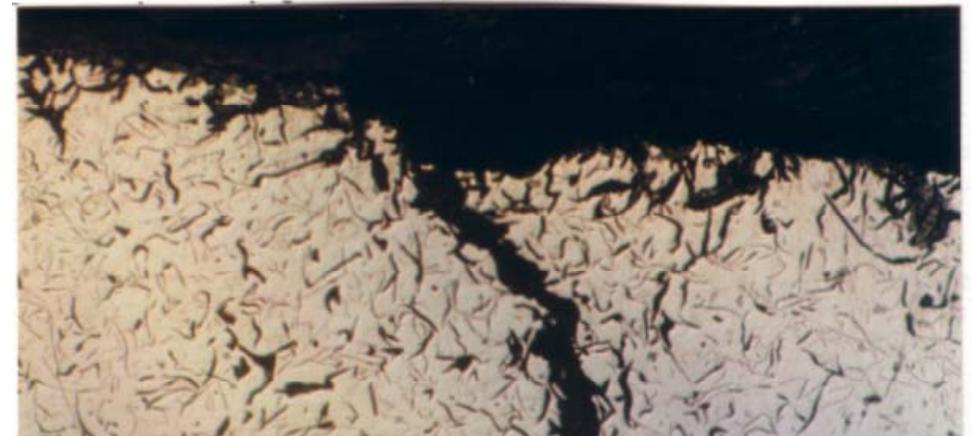
Metallographic examination of the cast iron plug, see Fig. 10 revealed that

Fig. 10 Microstructure at 75X showing corrosion, along Graphite flakes and intergranular cracking.

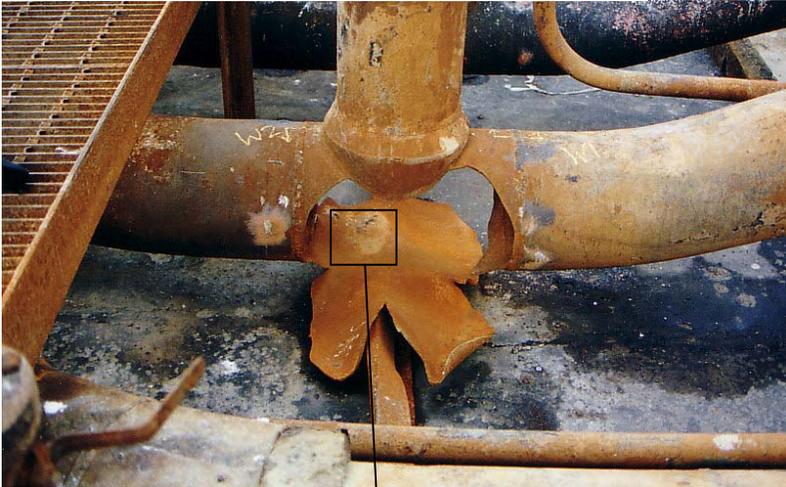
Further examination of the explosion damage, revealed a mark on the bottom of the line seen, immediately below the valve plug which had fractured, see Fig. 11. This section of the pipe was examined in the laboratory and, under microscopic examination, a small region was seen where impact damage had occurred had caused melting of the surface of the steel pipe and removal of the oxide layer, see Fig. 12.

Fig.11 Exploded region of pipework which was initially considered to be a secondary effect, note oxide

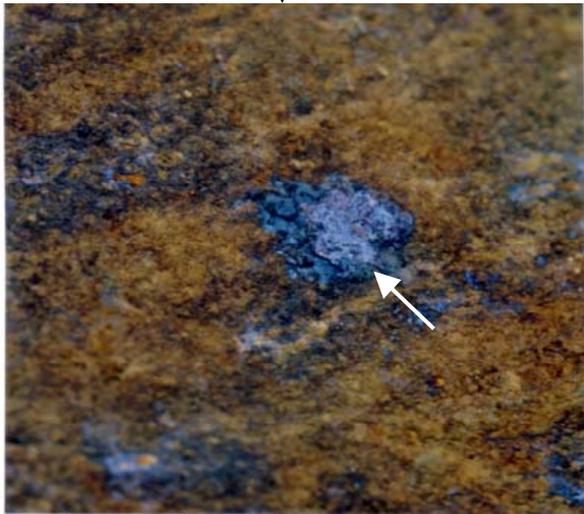
Fig. 12 View under microscope of exploded section of pipe, note melting of oxide layer. Indicative of initiation point of explosion.

In many investigations, there are a range of possible causes. The evidence from this investigation supports the view that at a time when the pipeline contained a potentially explosive mixture of air and hydrocarbon, the valve plug had fractured and fallen 1.5 metres to the main pipe beneath. This had produced a source of ignition which initiated the explosion.
